# The Dock Frog Marine Survey & Consultation

## “Endurance 37”

# **Report of Marine Survey**

## **“ Endurance 37”**

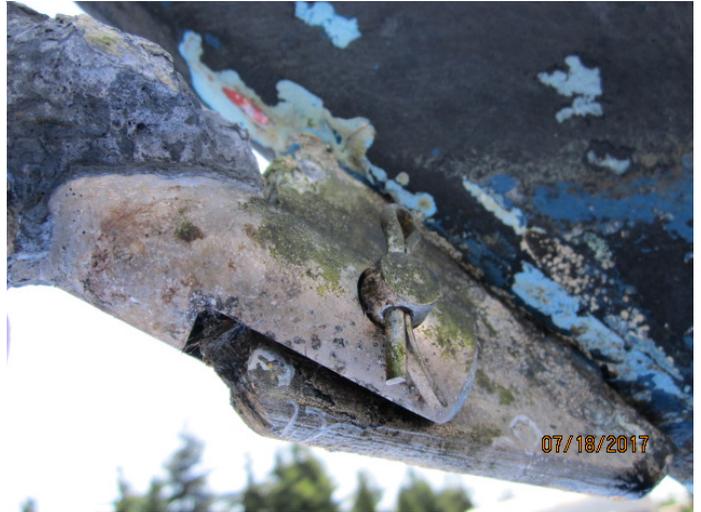
S/S shrouds and stays sighted to be in fair condition with bobstay sighted to be in poor condition with a wasted anode and heavy corrosion at waterline.

**Bobstay at hull**

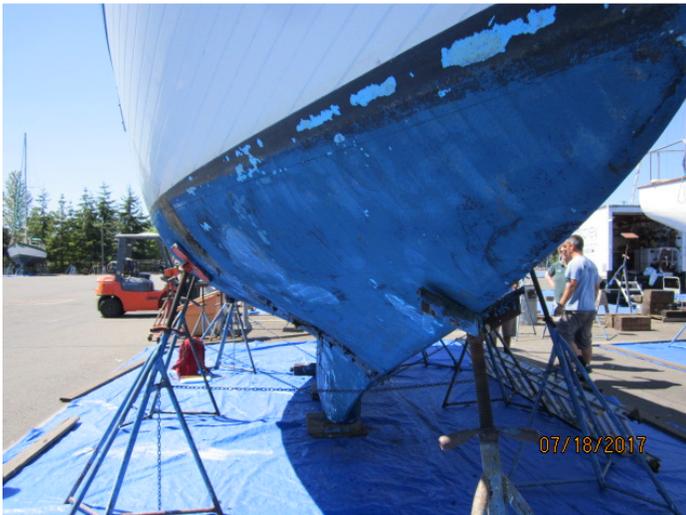
Painted white finish with paint blisters sighted along 1" above boot strap \*B1

**Hull STBD**

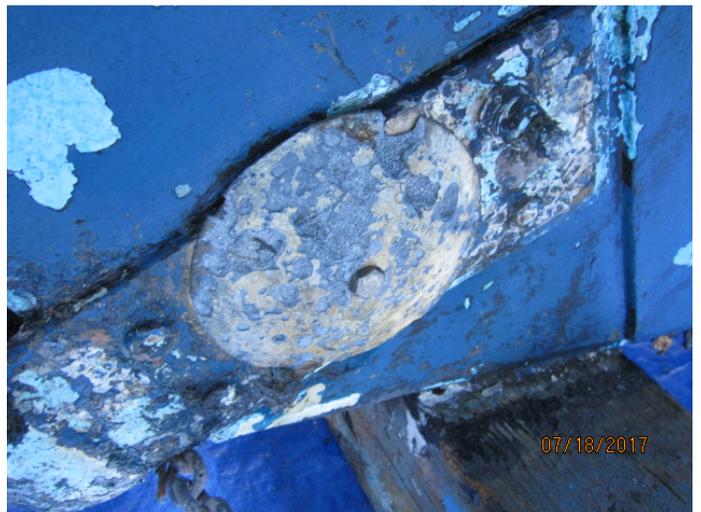
S/S Skeg was painted over and showed signs of corrosion but appeared to be in fair condition. \*B18.

**Skeg**

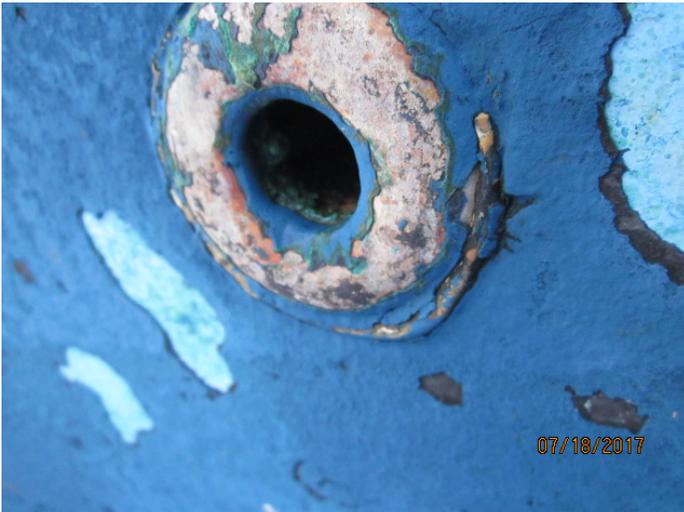
Were sighted to have mild galvanic corrosion. \*B20.

**Thru Hull Fitting**

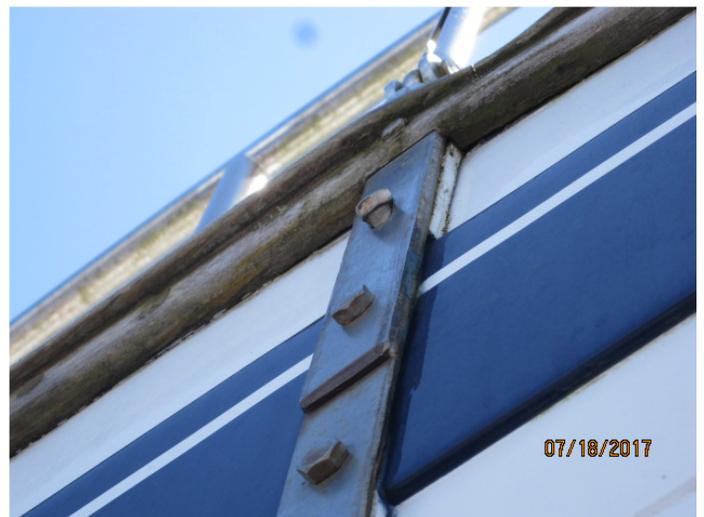
S/S external chainplates were sighted to be in fair condition with mounting hardware sighted to be misaligned and bottom of chain plate separating from hull. Internal chainplates could not be sighted. \*B5.

**STBD Chain plate**

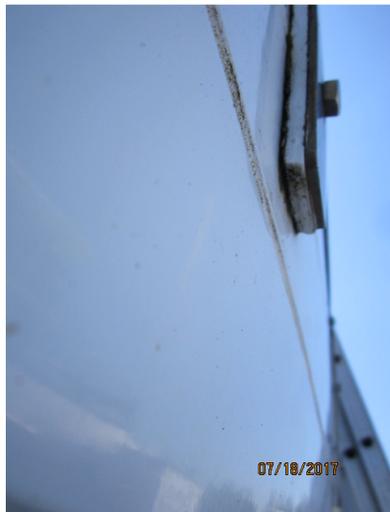
**Port chain plate**

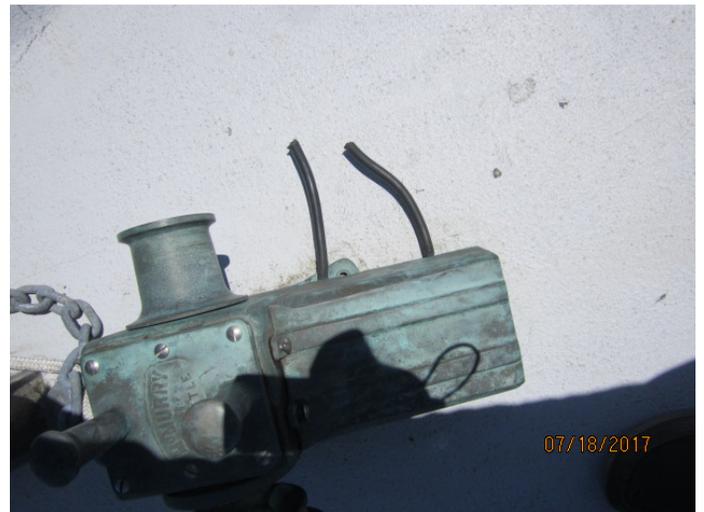
**Unmounted windlass**

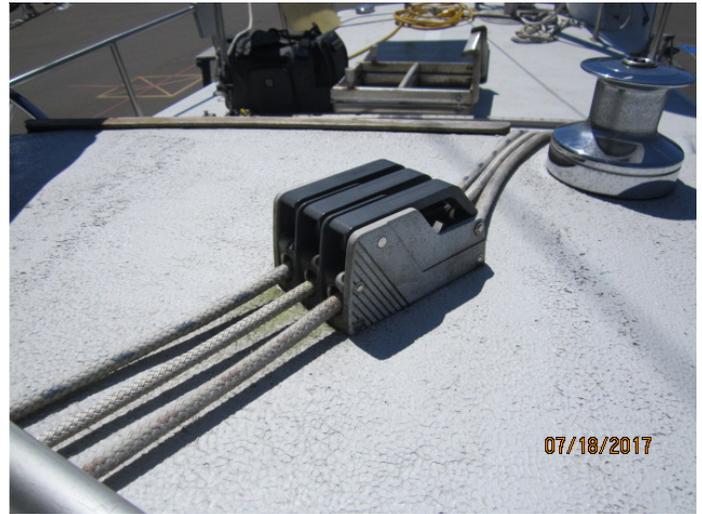
Standing rigging was sighted to be loose but in fair condition, running rigging was operable but in poor condition. \*A1.

**Running rigging sun damaged**

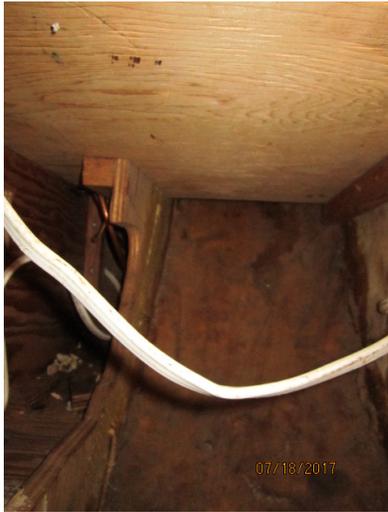
Was sighted to be unsupported in areas with exposed or disconnected wires sighted and improper connections used. Sighted to be in poor condition. \*A14.

**Unsupported AC wiring**

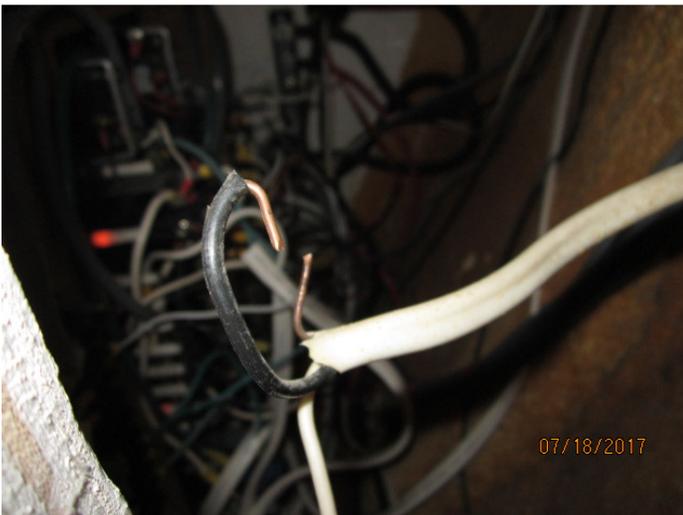
Was sighted to be unsupported in area with wire nuts, unconnected wiring and, household solid wiring was sighted in areas. sighted to be in poor condition. \*A14.

**Unprotected household AC wiring**

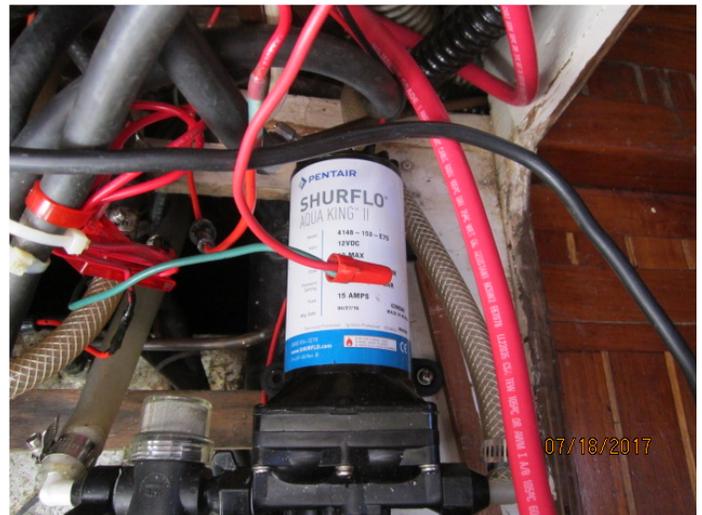
**Wire nut on DC wiring/Water pump**

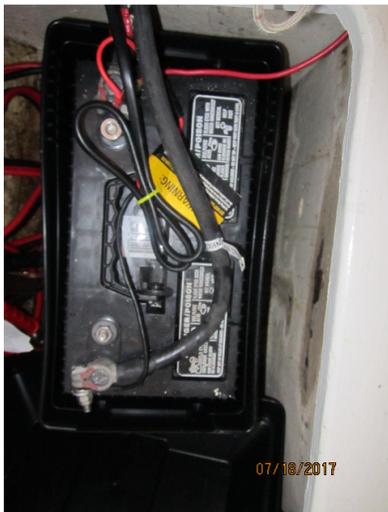
1 loose Group 27 wet cell battery was sighted in STBD forward lazarette. \*B12.

**Unsecured house battery**

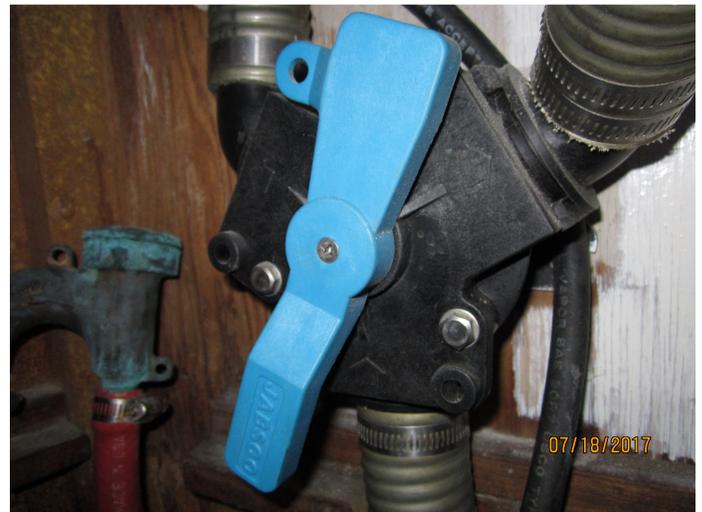
**Unlocked blackwater y-valve**
